Jefferson Proving Ground
Madison
Jefferson County
Indiana

HAER No. IN-54

WRITTEN HISTORICAL AND DESCRIPTIVE DATA

Jefferson Proving Ground

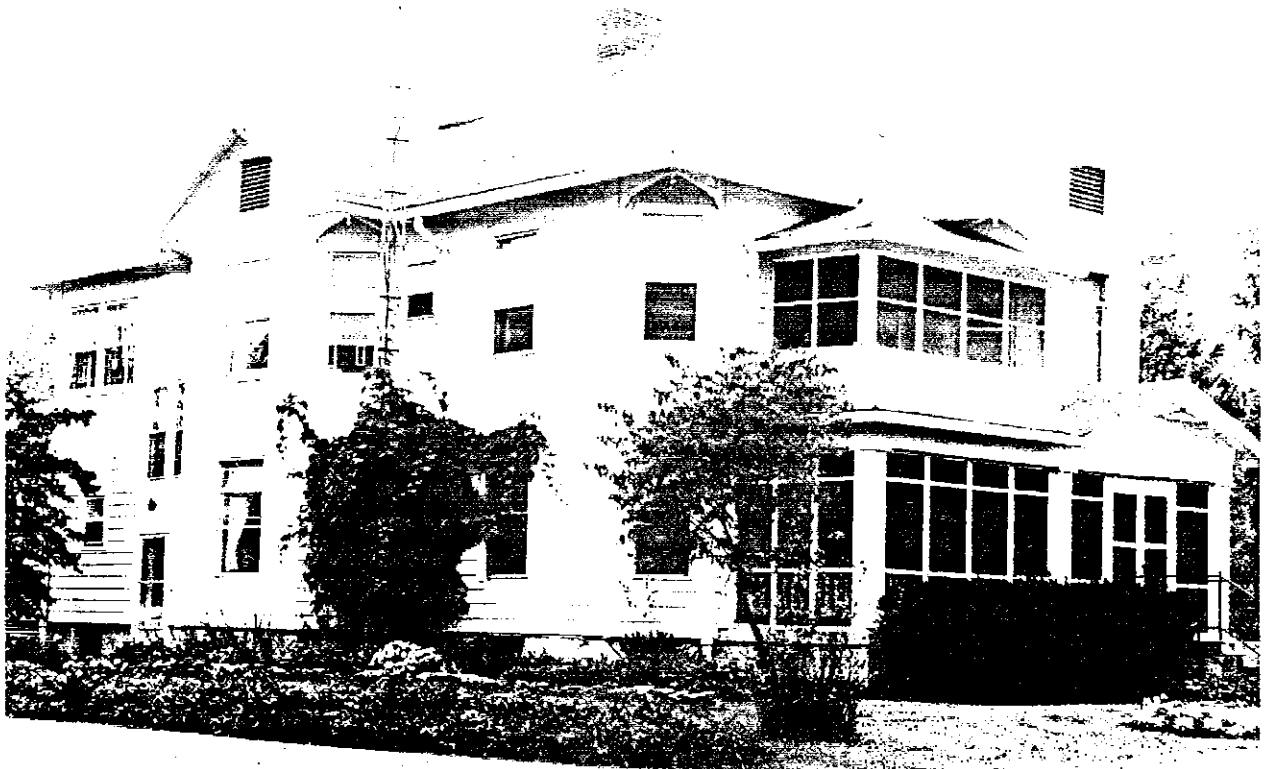
Illustration 3 Commanding Officer's house (Building 1). This structure is the largest of the proving ground's 13 houses, which are grouped around the U-shaped parade ground in the southern portion of the main base area. All 13 were relocated from other parts of the proving ground after acquisition by the Army in 1941. (Source: Field inventory photograph, 1983, William Brenner, Building Technology, Inc.)

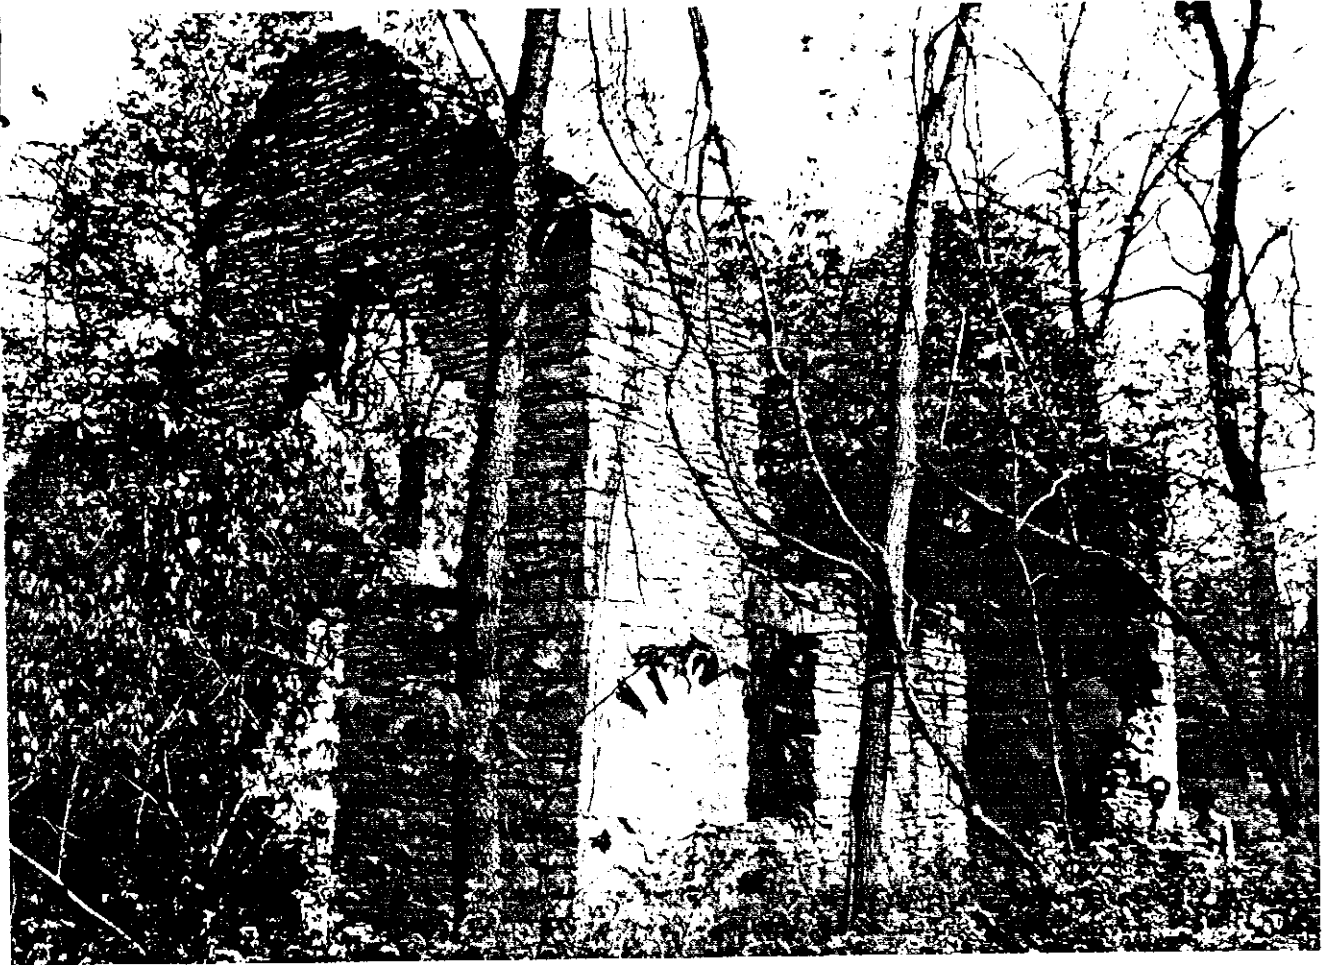
Illustration 7 House ruin. This is one of two substantial house ruins at the proving ground. The building was two stories high and covered with cement stucco. (Source: Field inventory photograph, 1983, William Brenner, Building Technology, Inc.)

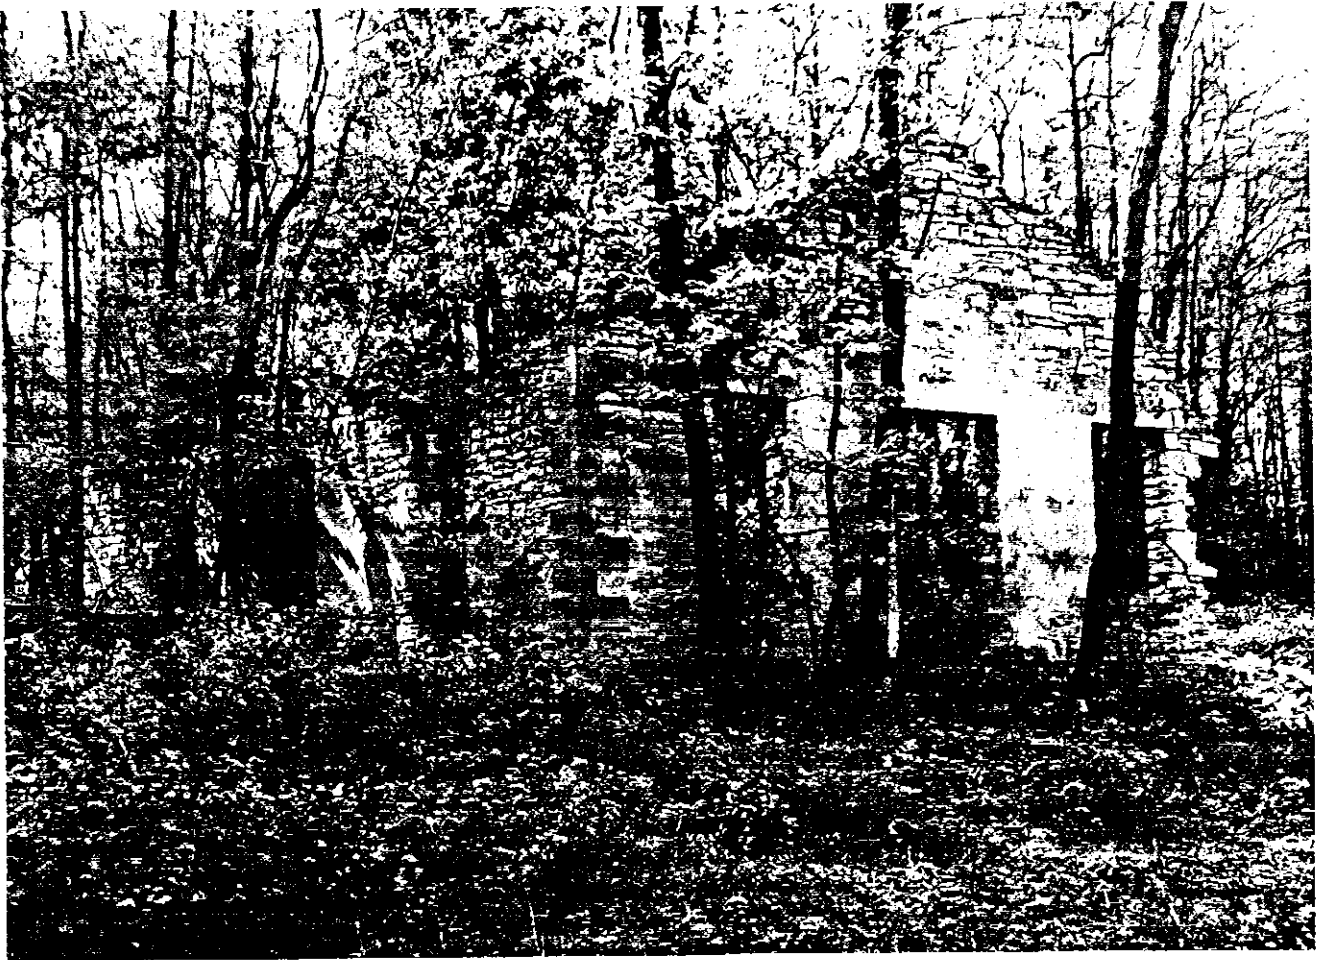
church, only two walls of which are now standing, had dressed limestone quoins on the corners of its front elevation. Little exists of these structures but portions of their stone walls. (Illustrations 7 and 8)

Illustration 8 Church ruins. Located mid-range, this structure was covered with cement stucco and had cut stone quoins at both corners of its front facade. Like the house in Illustration 7, little remains but its exterior walls. (Source: Field inventory photograph, 1983, William Brenner, Building Technology, Inc.)

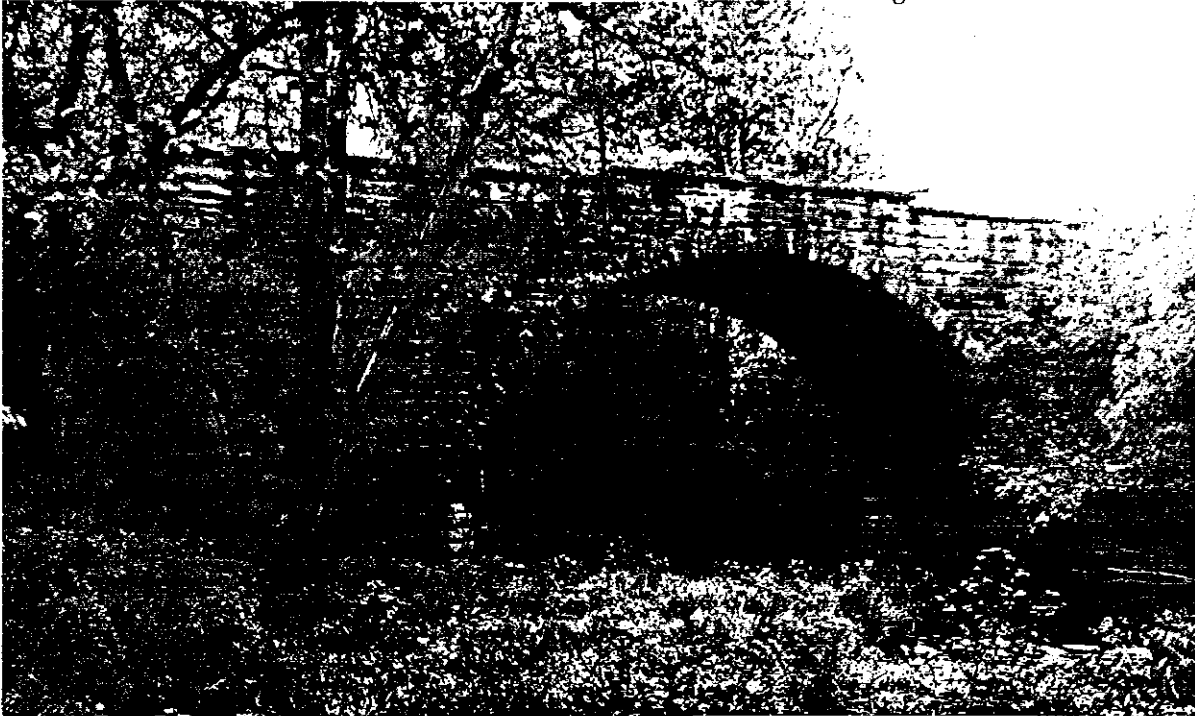
- Bridges. A variety of nineteenth and early twentieth century bridges, all undated, are located in the uprange area. The earliest are the stone arch bridges (Bridges 17, 25, 27, and 28). Bridge 25 has a single arch, Bridges 17 and 28 have two arches, and Bridge 27 has three arches. All four are expertly constructed of coursed limestone in a simple but elegant design. Five metal truss structures (Bridges 2, 3, 6, 8, and 10), probably erected between the 1890s and the 1920s, form a second group of bridges. They are Pratt truss bridges of various spans and dimensions. A single reinforced concrete arch bridge (Bridge 22) is also located uprange. It has a single span of about 60 feet, and was probably built sometime between 1910 and the 1930s. It may be a WPA era bridge, although there are no visible markings to this effect. The structure shows signs of damage and deterioration but is still in service. The earlier stone arch and metal truss bridges also remain in use, but are in good condition. (Illustrations 9, 10, and 11)

Illustration 9 Stone arch bridge. Of the four stone arch bridges at the proving ground, this structure, with three arches of about 40 feet each, is the largest. The four bridges are similar in their use of coursed limestone and in their quality craftsmanship. All are highly intact and are currently in service. (Source: Field inventory photograph, 1983, William Brenner, Building Technology, Inc.)

- Preservation recommendations. The four bridges should be routinely maintained and all original features should be kept intact. When mortar repairs are made, the original mortar should be duplicated in strength, color, composition, and texture. Mortar joints should be duplicated in width and in joint profile. Stonework repairs should be made with like materials and follow the structural principles upon which each bridge was built.

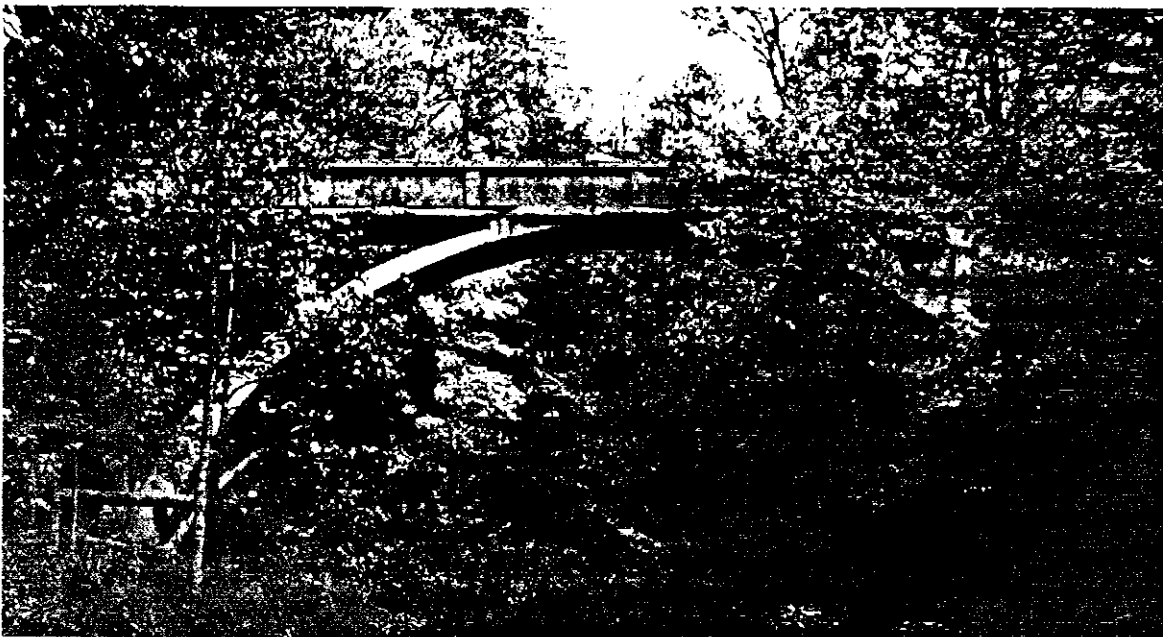
Illustration 10 Reinforced concrete arch bridge. This is the only concrete arch bridge on the proving ground. It spans about 60', and while the concrete is deteriorated and damaged in some places, it is still structurally sound. (Source: Field inventory photograph, 1983, William Brenner, Building Technology, Inc.)

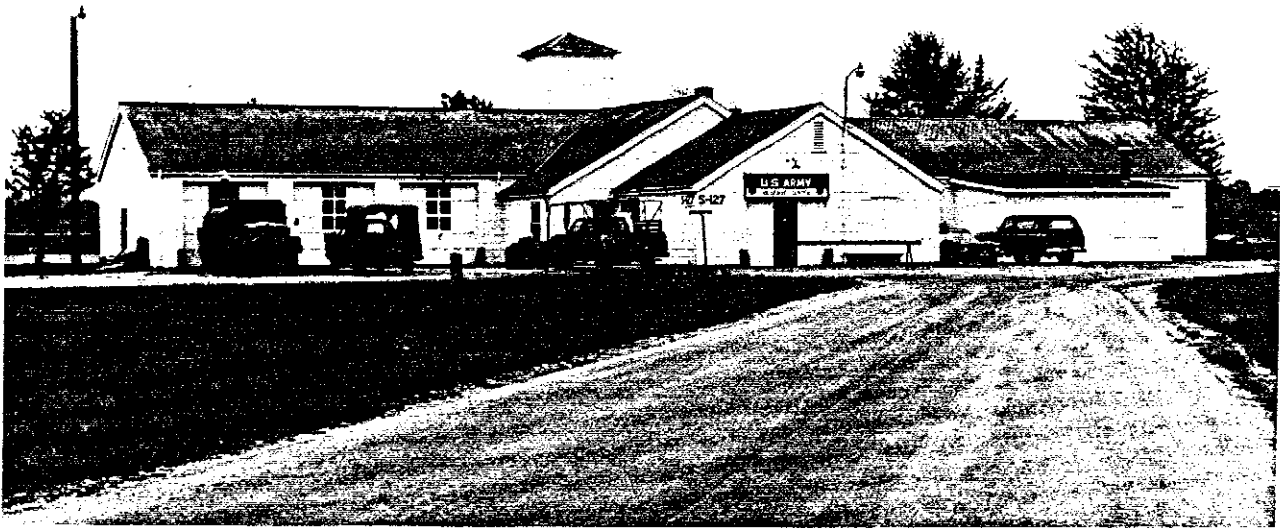
Illustration 15 Building 127. View of southwest facade. Building 127 is one of the several remaining semi-permanent buildings constructed on the installation during World War II. It is of wood frame construction clad with asbestos cement shingles. It has served as an Army Reserve Center since 1941. (Source: Field inventory photograph, 1983, William Brenner, Building Technology, Inc.)

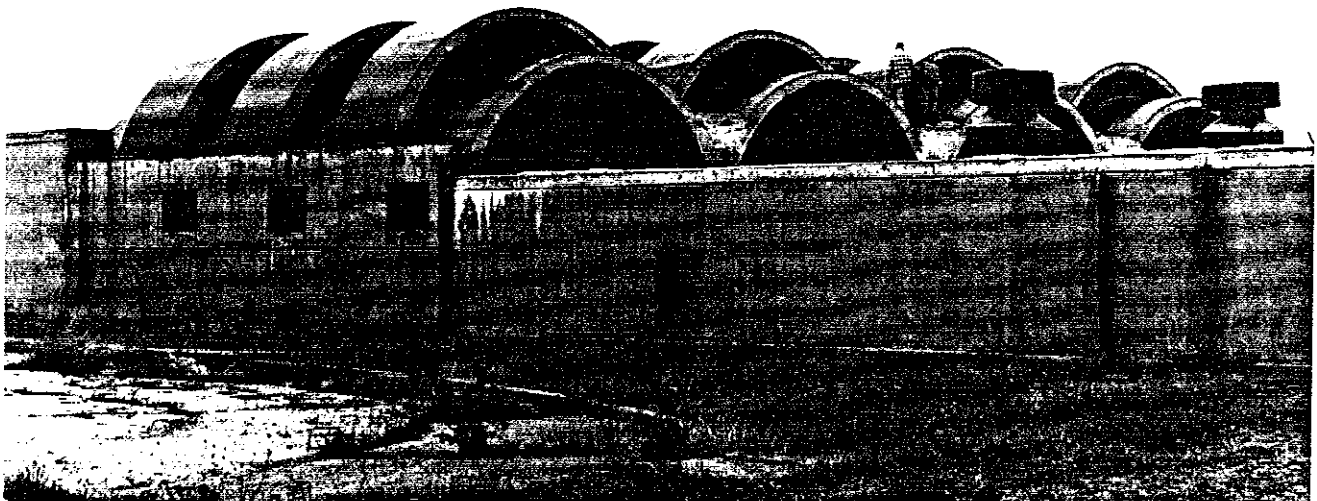
Illustration 16 Building 295. View of east and north elevations. This reinforced concrete structure was built as a small arms firing range in 1943. The portion of its roof shown here is located over the firing line. (Source: Field inventory photograph, 1983, William Brenner, Building Technology, Inc.)
